REPORT OF  
INVESTIGATION & DEVELOPMENT  
OF  
PRELIMINARY COSTS TO REHABILITATE  
WORSHAM STREET BRIDGE

FOR  
CITY OF DANVILLE, VIRGINIA  
DEPARTMENT OF PUBLIC WORKS

AUGUST 2, 2004

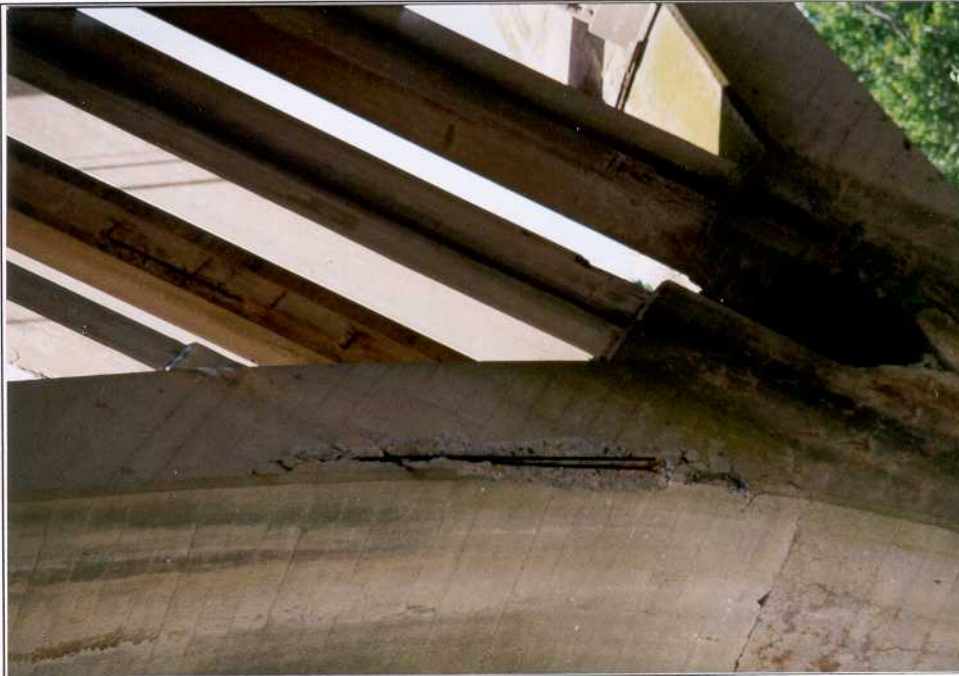
**A104-20**

**SPALLING, CRACKING AND CORRODED REBAR IN DOWNSTREAM ARCH, SPAN D NEAR PIER 5.**

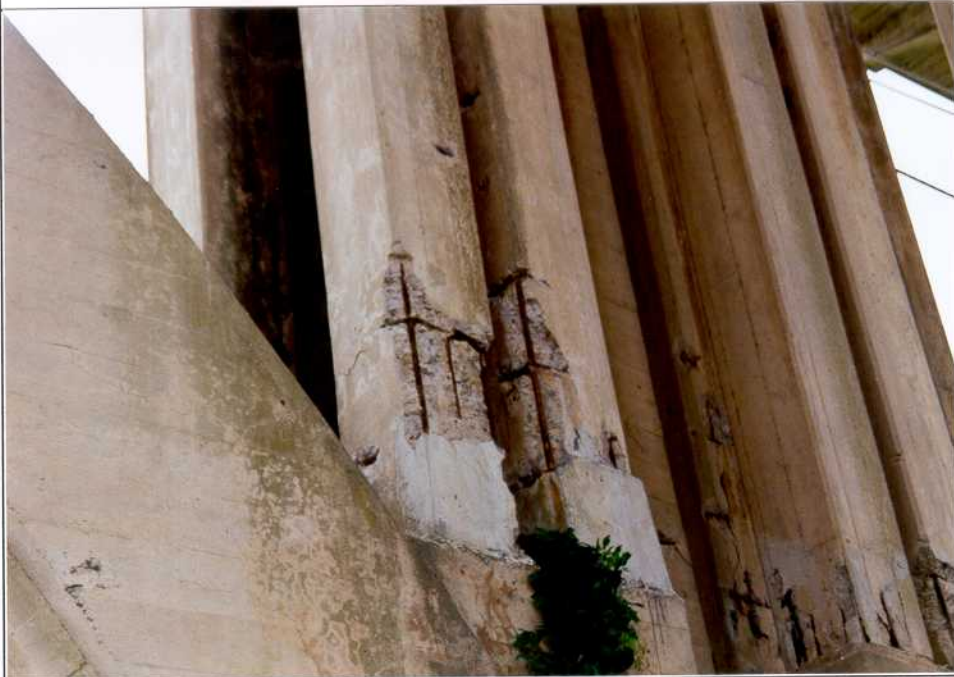
**C215-20**

**SPAN D, COLUMNS C1 AND C2 - NOTE DETERIORATED CONCRETE WITH EXPOSED REINFORCING STEEL.**

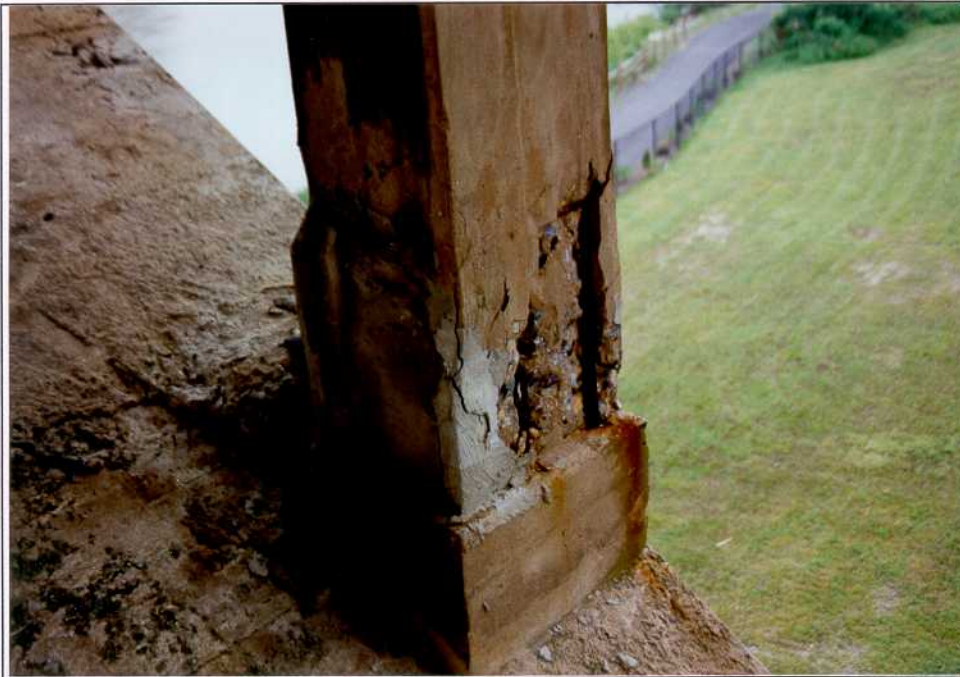
**C216-8**

**COLUMN D4, SPAN D - NOTE SPALLED CONCRETE WITH EXPOSED REINFORCING STEEL AT BOTTOM OF COLUMN.**

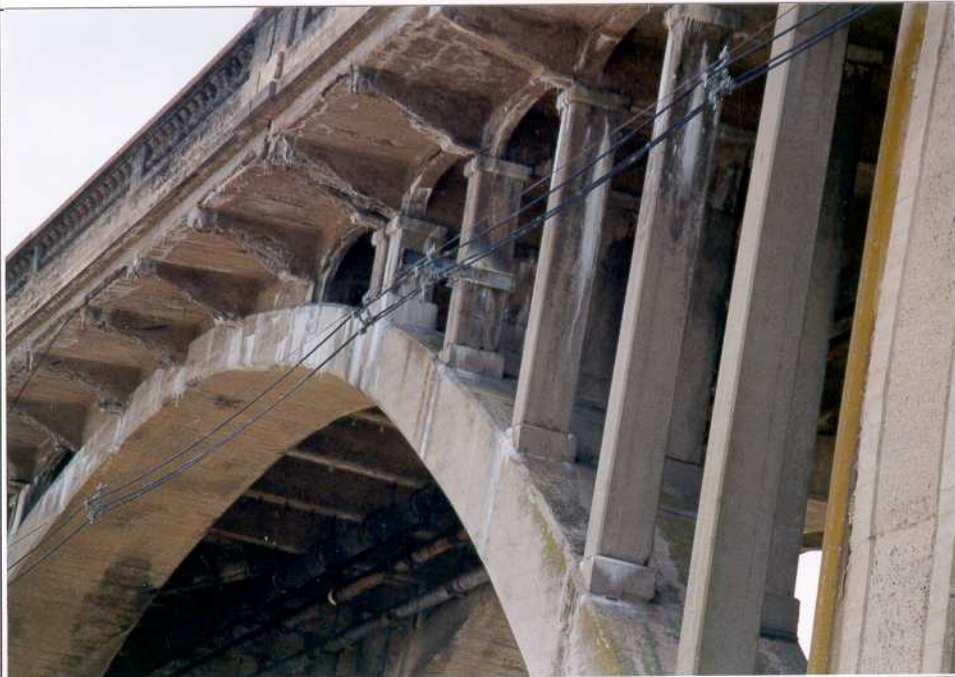
**A105-2**

**SEVERE DETERIORATION, DECK, FLOORBEAMS, COLUMNS, DOWNSTREAM ARCH, NEAR CROWN, SPAN E.**

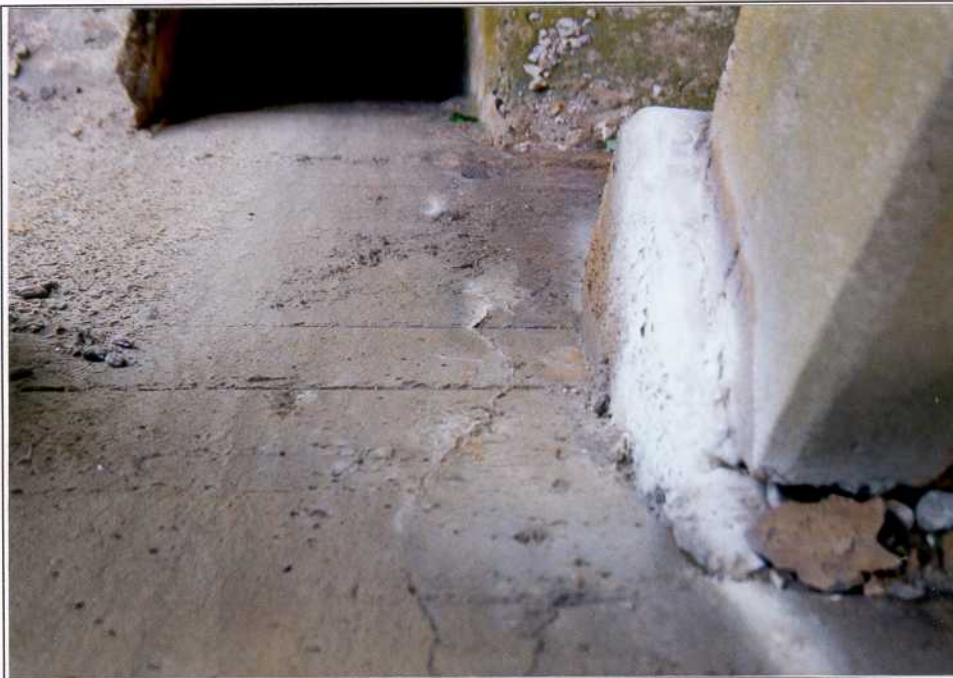
**C217-10**

**LONGITUDINAL CRACK WITH EFFLORESCENCE ON TOP OF  
DOWNSTREAM ARCH, SPAN G.**

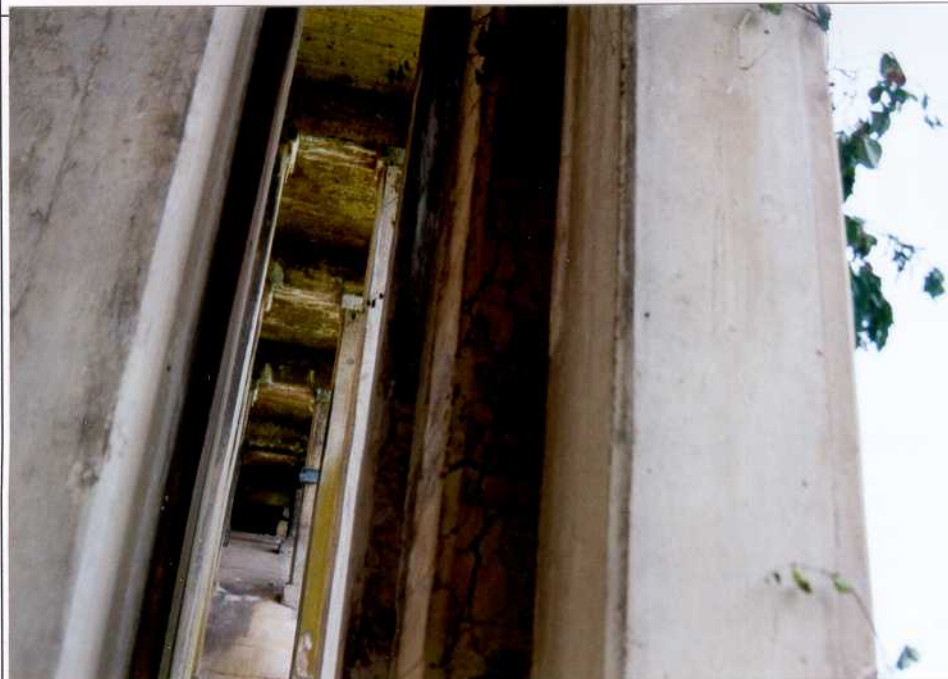
**C217-12**

**COLUMN A1, SPAN H - NOTE SPALLING AND DELAMINATED  
CONCRETE.**

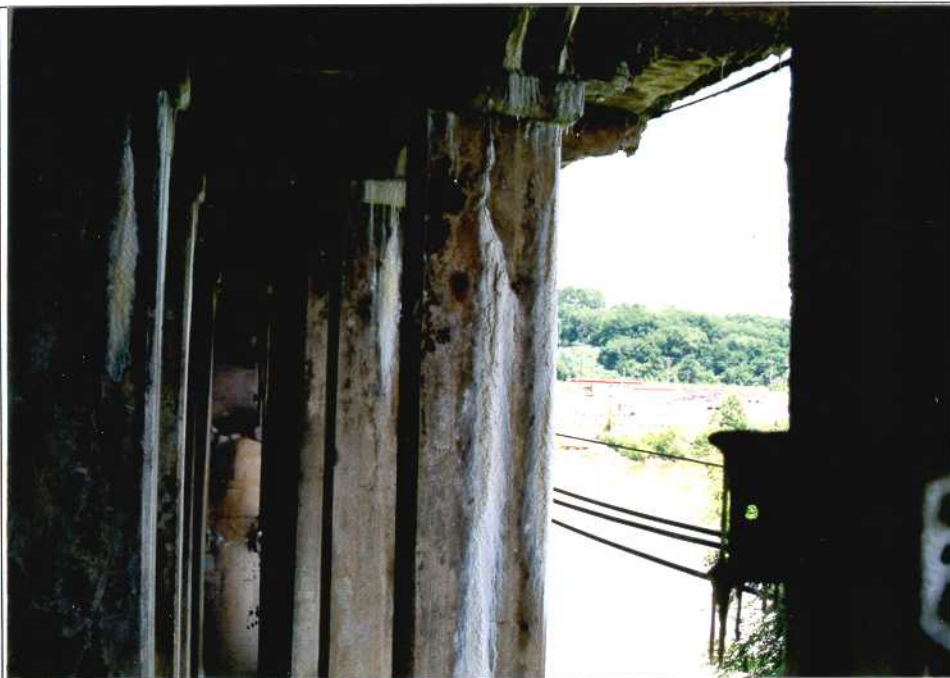
C217-11

**COLUMN A4, SPAN H - NOTE CRACKING WITH EFFLORESCENCE**

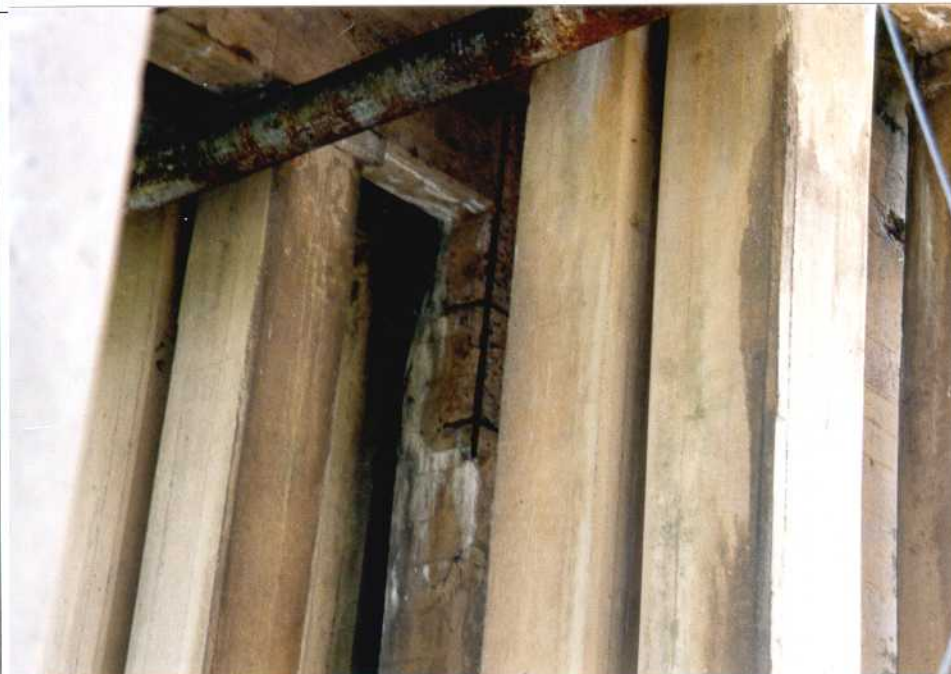
C217-9

**COLUMN D1, SPAN H - NOTE SPALLED CONCRETE WITH EXPOSED REINFORCING STEEL.**

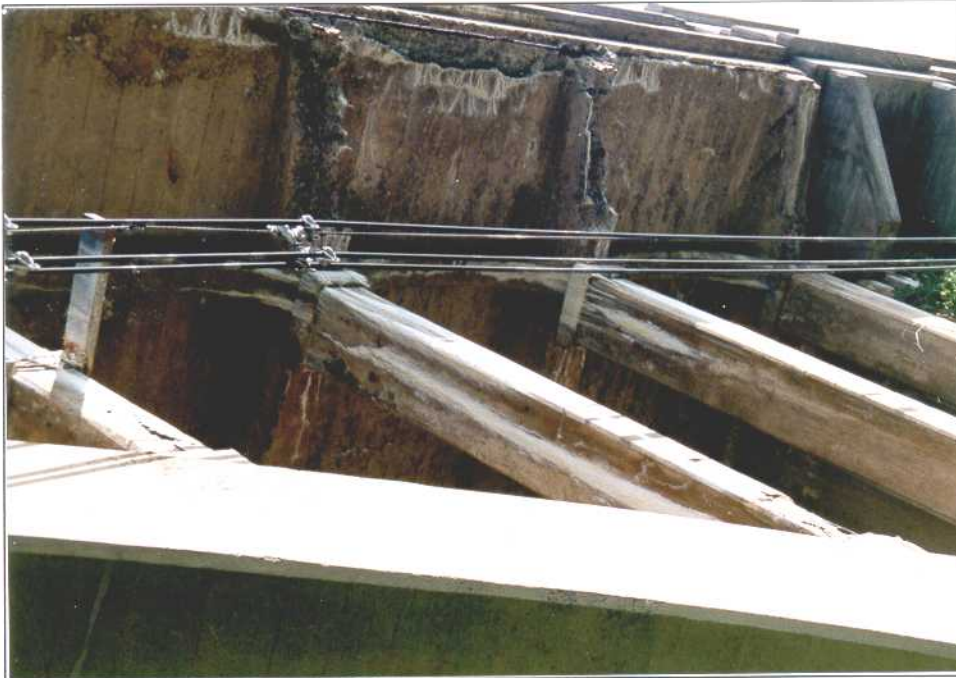
A104-5

**SEVERE DETERIORATION, FLOORBEAM, DECK, COLUMNS,  
DOWNSTREAM SIDE, SPAN H.**

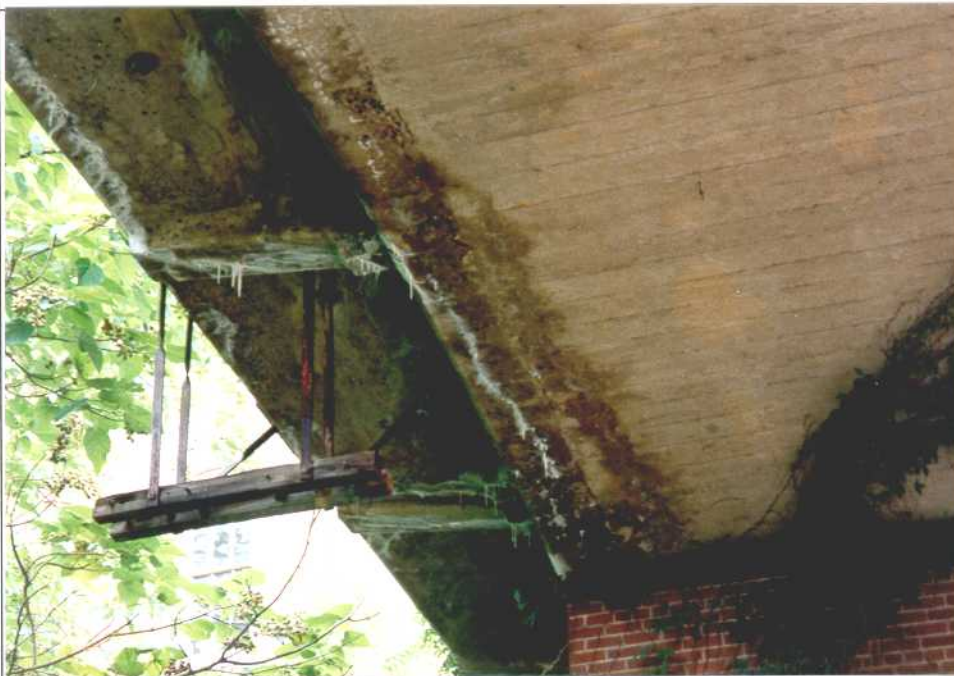
C216-1

**SPAN J, DOWNSTREAM SIDE, NEAR ABUTMENT 11 - NOTE  
SPALLED CONCRETE AND EFFLORESCENCE ON UNDERSIDE OF  
DECK OVERHANG AND ARCH.**

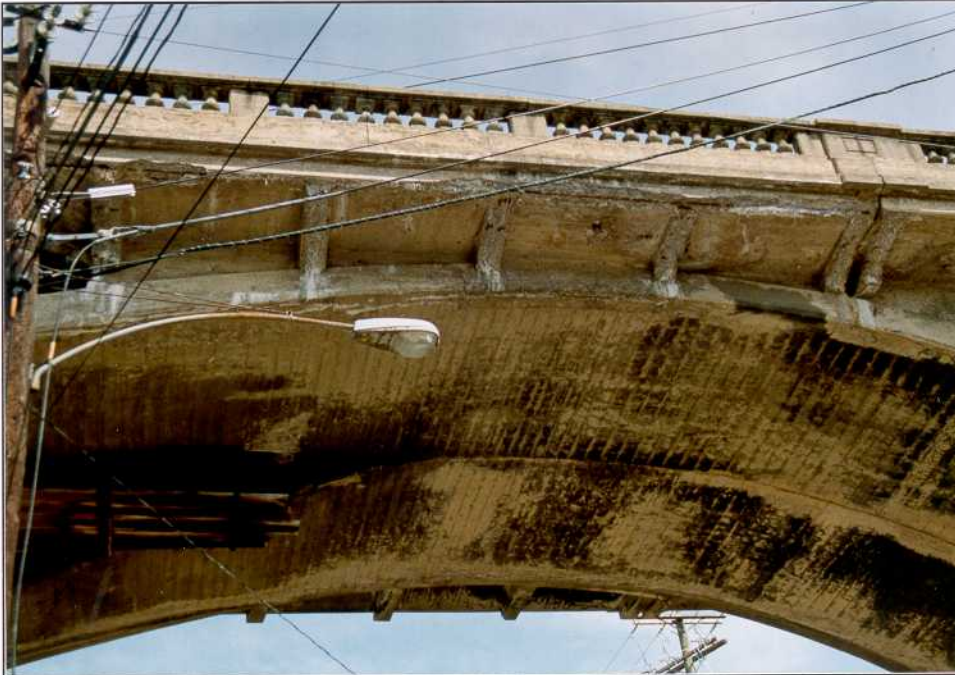
**A104-6**

**SEVERE DETERIORATION, FLOORBEAM, DECK, ARCH CROWN,  
DOWNSTREAM SIDE, SPAN B OVER ROUTE 58.**

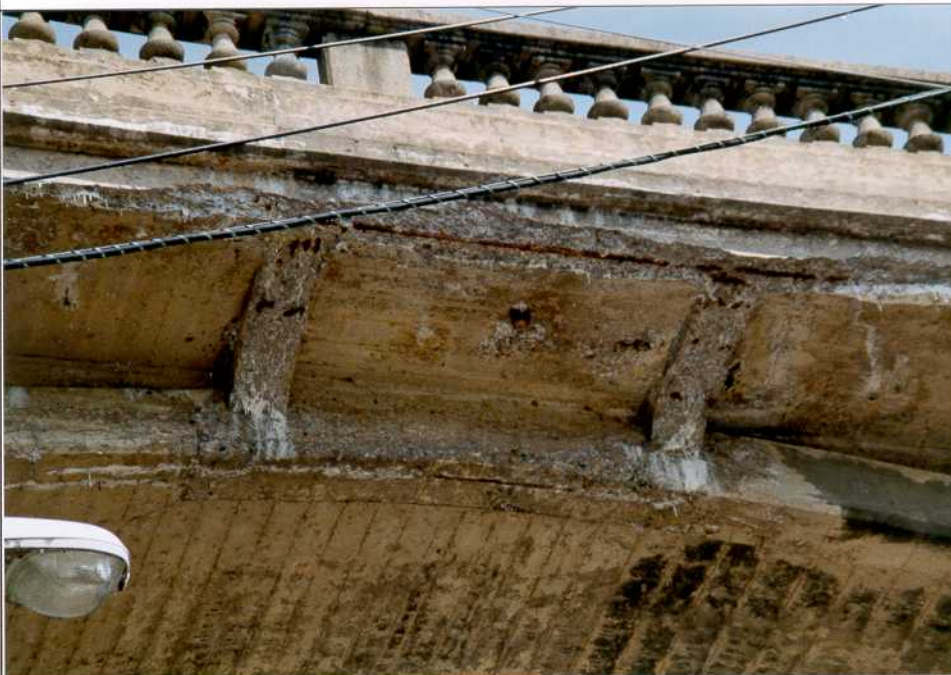
**A104-7**

**SEVERE DETERIORATION, FLOORBEAM, DECK, ARCH CROWN,  
DOWNSTREAM SIDE, SPAN B OVER ROUTE 58.**

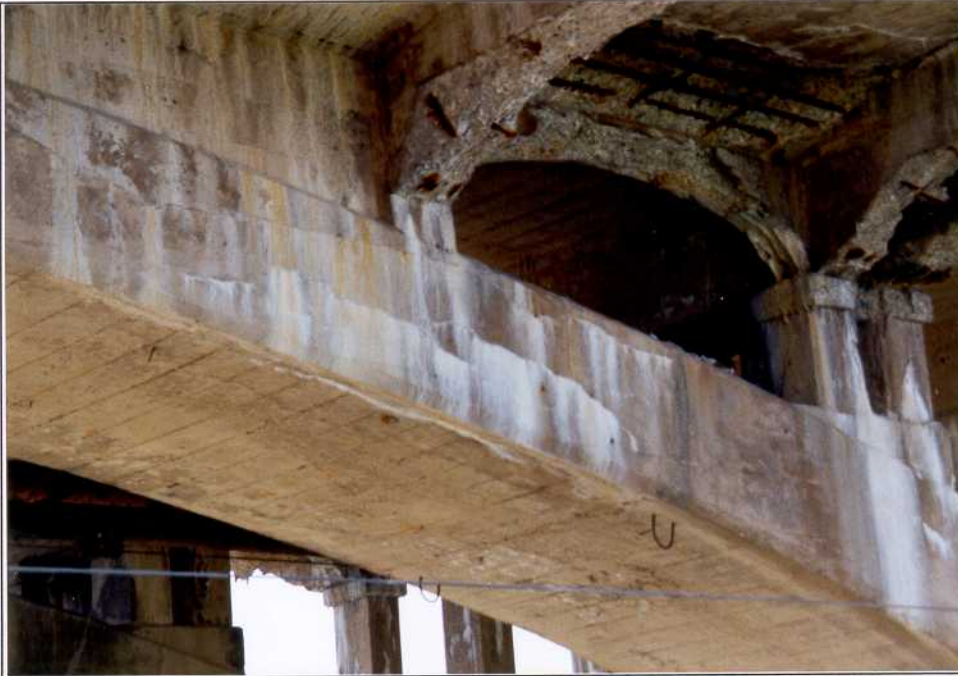
C216-19

UPSTREAM ARCH, SPAN B - NOTE CRACKS AND EFFLORESCENCE ON SIDE OF ARCH.

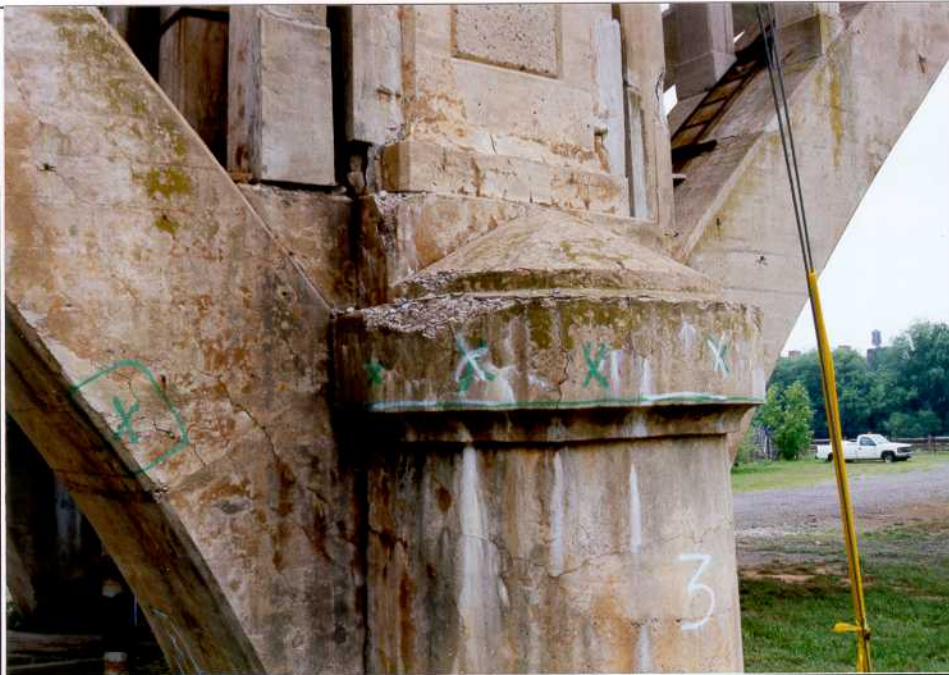
C215-14

PIER 3, UPSTREAM SIDE - NOTE DELAMINATED AND SPALLED CONCRETE.

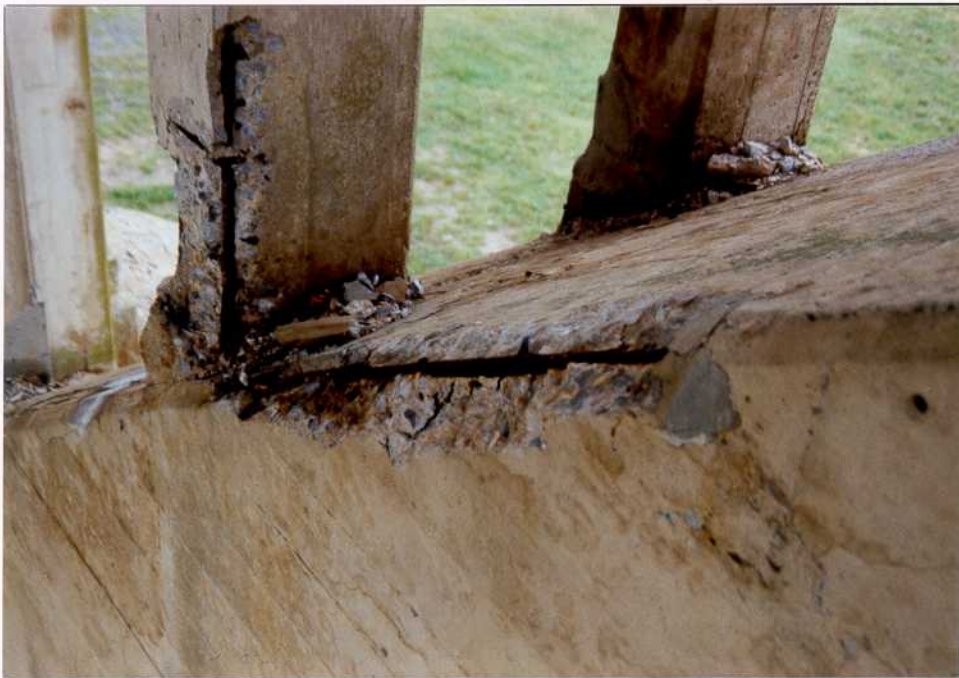
**C216-5**

**UPSTREAM ARCH, SPAN C - NOTE SPALLED CONCRETE WITH EXPOSED REINFORCING STEEL.**

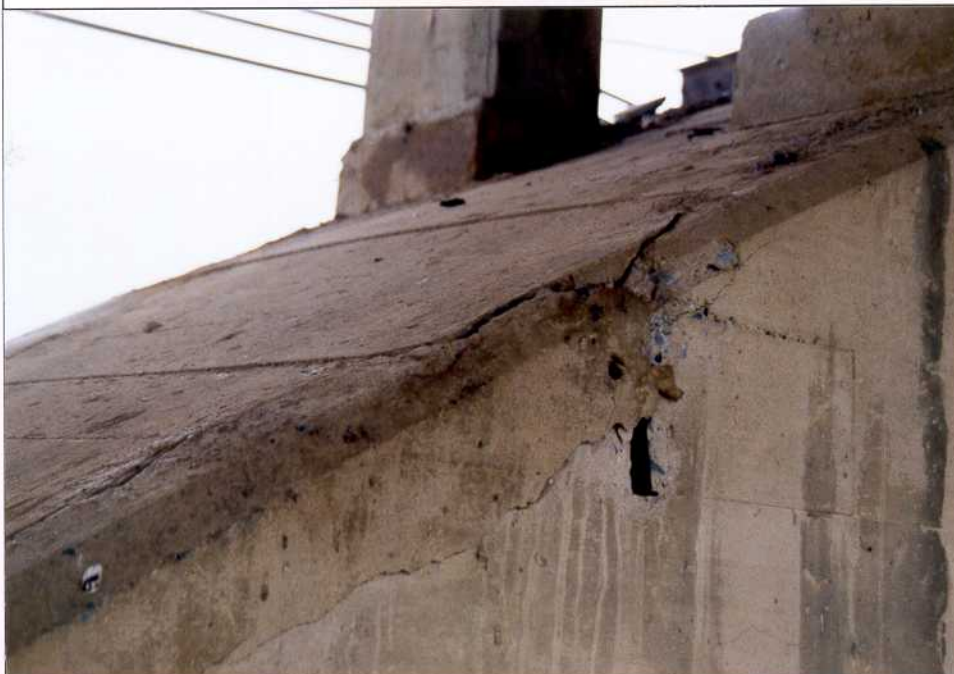
**C216-6**

**UPSTREAM ARCH, SPAN C - NOTE DELAMINATED CONCRETE.**

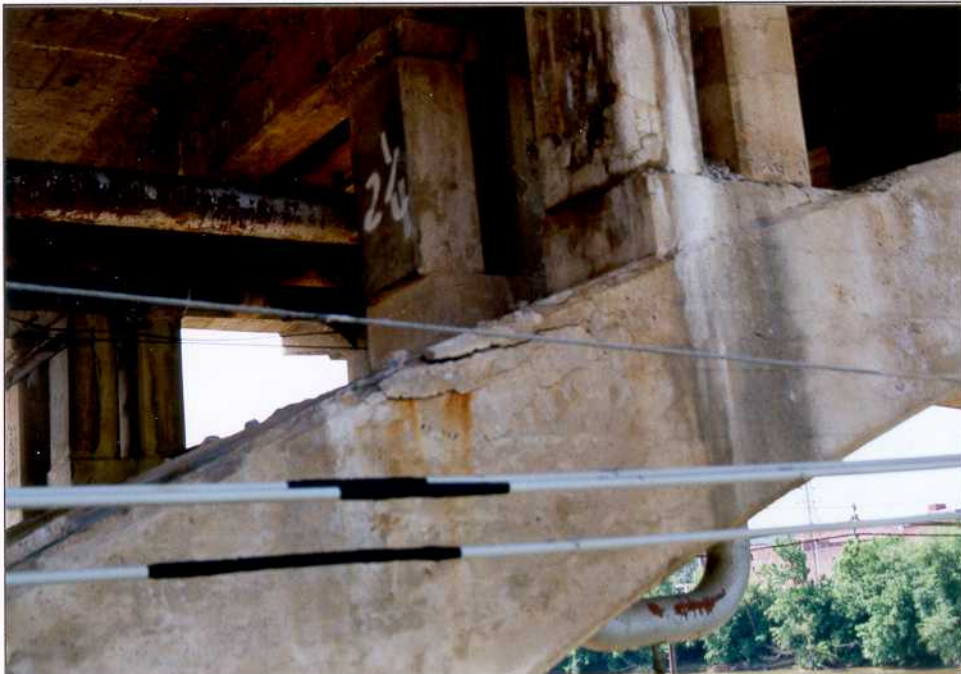
C216-14

UPSTREAM ARCH, SPAN C - NOTE SPALLED/DELAMINATED  
CONCRETE IN TOP OF ARCH.

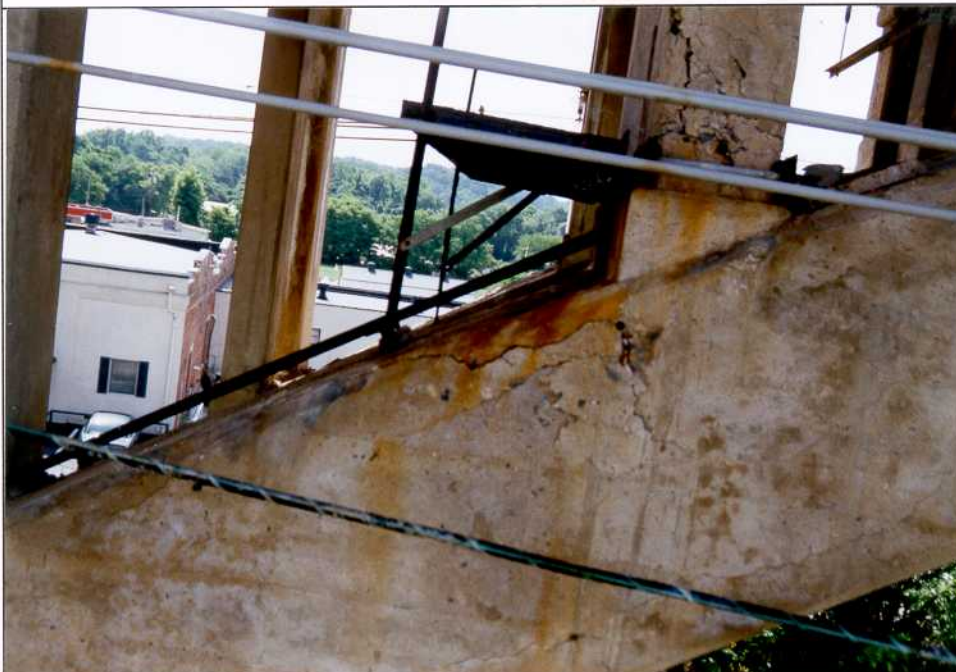
C216-15

UPSTREAM ARCH, SPAN C - NOTE DELAMINATED CONCRETE IN  
TOP OF ARCH.

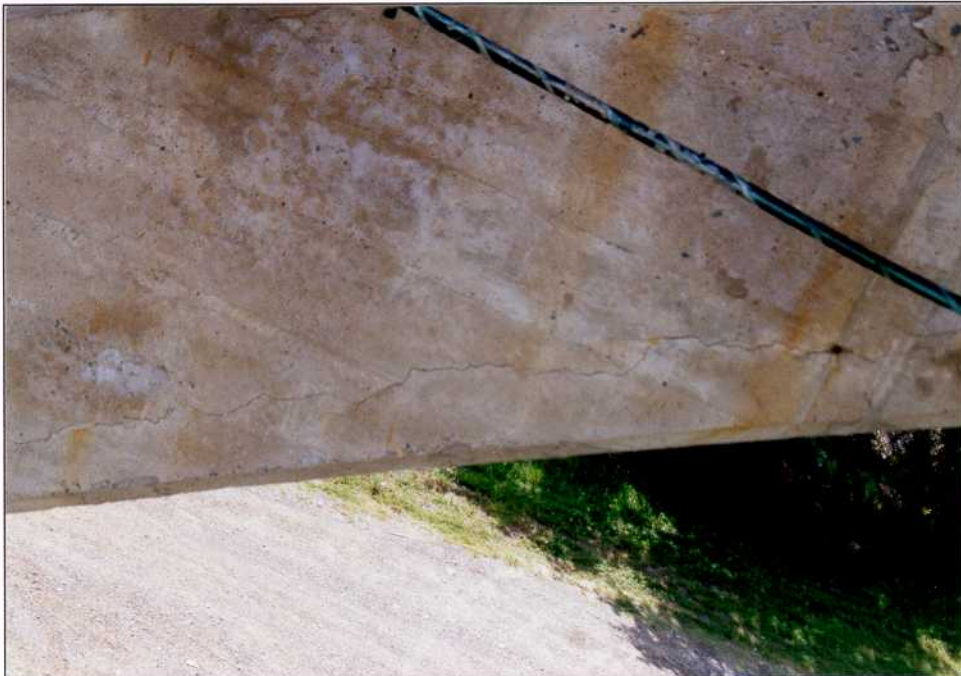
**C216-17**

**UPSTREAM ARCH, SPAN C - NOTE CRACKED AND DELAMINATED CONCRETE ON UPSTREAM SIDE.**

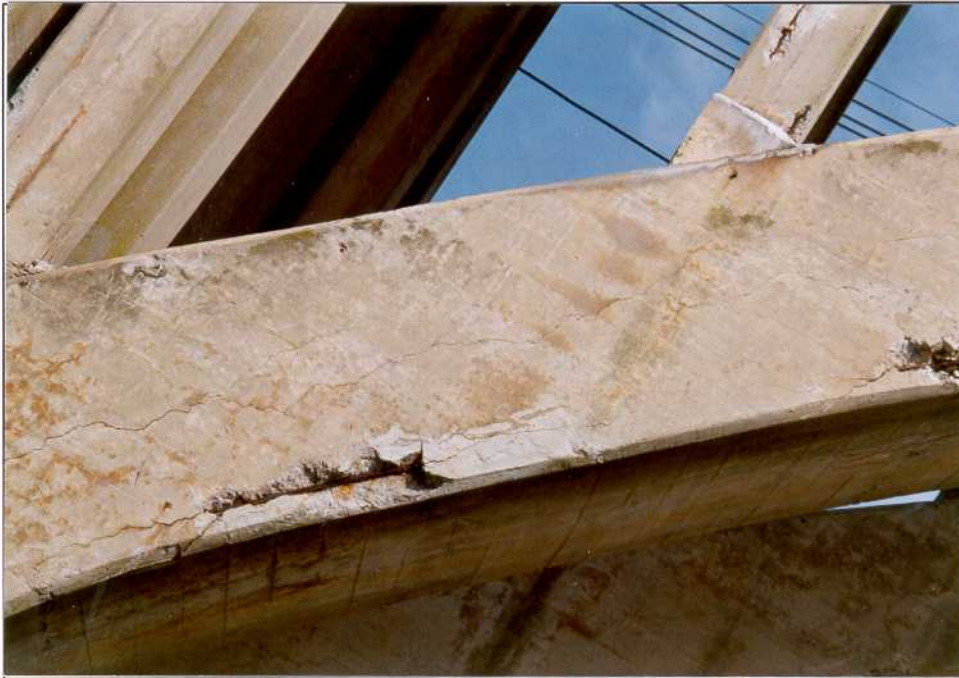
**A104-15**

**DELAMINATIONS, CRACKS AND CORRODED REBAR, SPAN C,  
DOWNSTREAM ARCH NEAR PIER 4.**

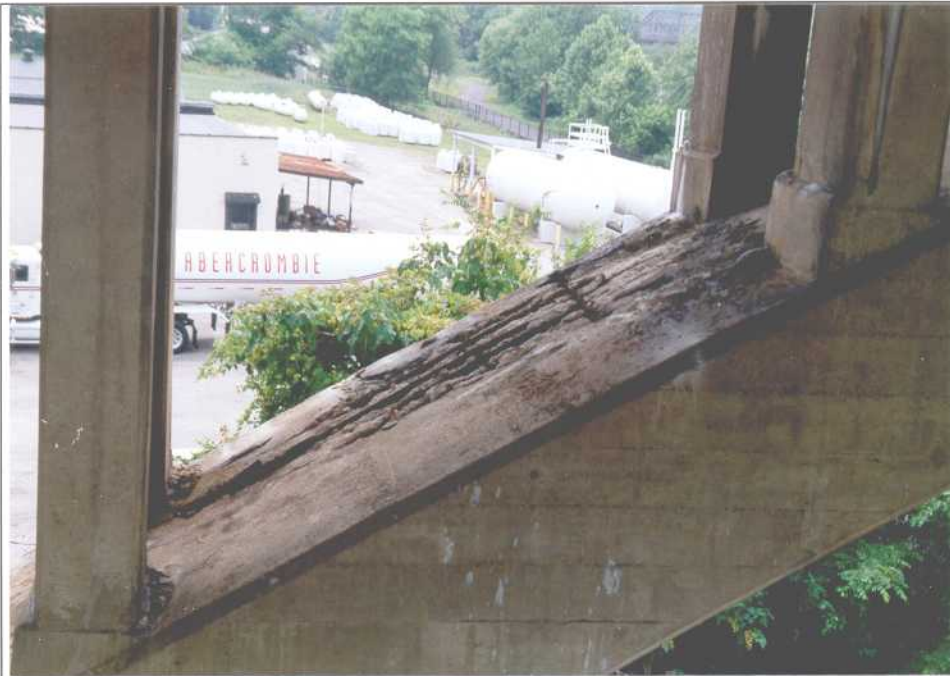
C215-7

**SPALL CONCRETE WITH EXPOSED STEEL, TOP DOWNSTREAM ARCH, SPAN C.**

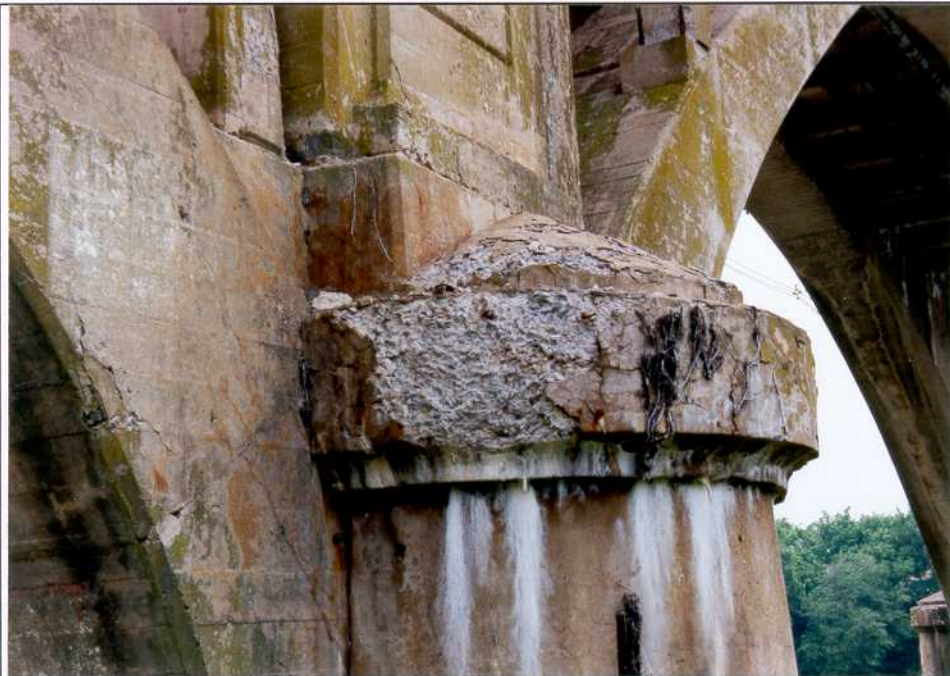
C215-15

**PIER 4, UPSTREAM SIDE - NOTE DELAMINATED AND SPALLED CONCRETE.**

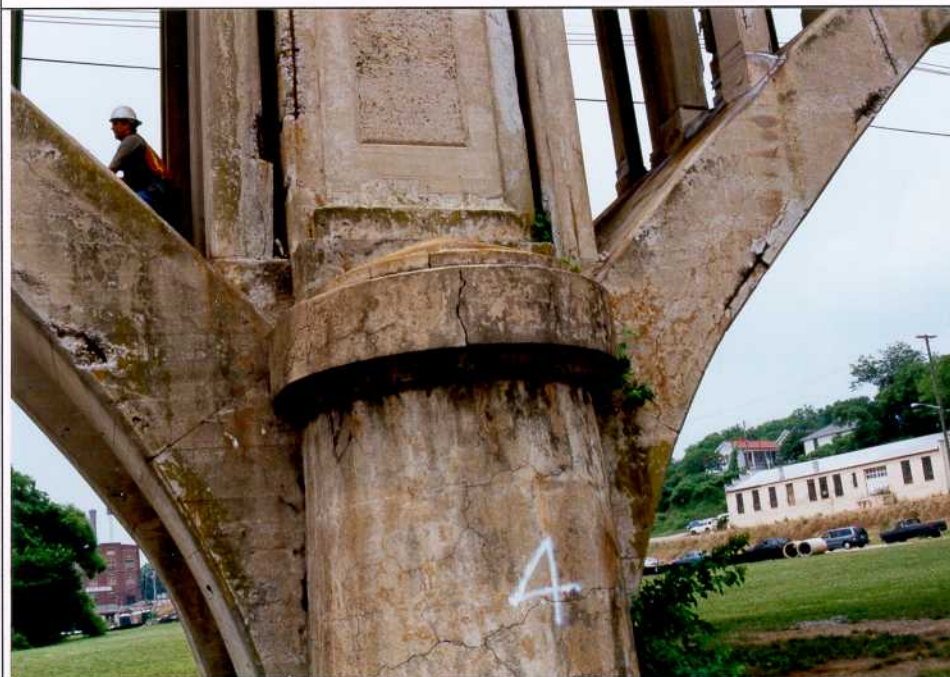
C215-18

**PIER 4, DOWNSTREAM SIDE - NOTE CRACKED AND DELAMINATED CONCRETE.**

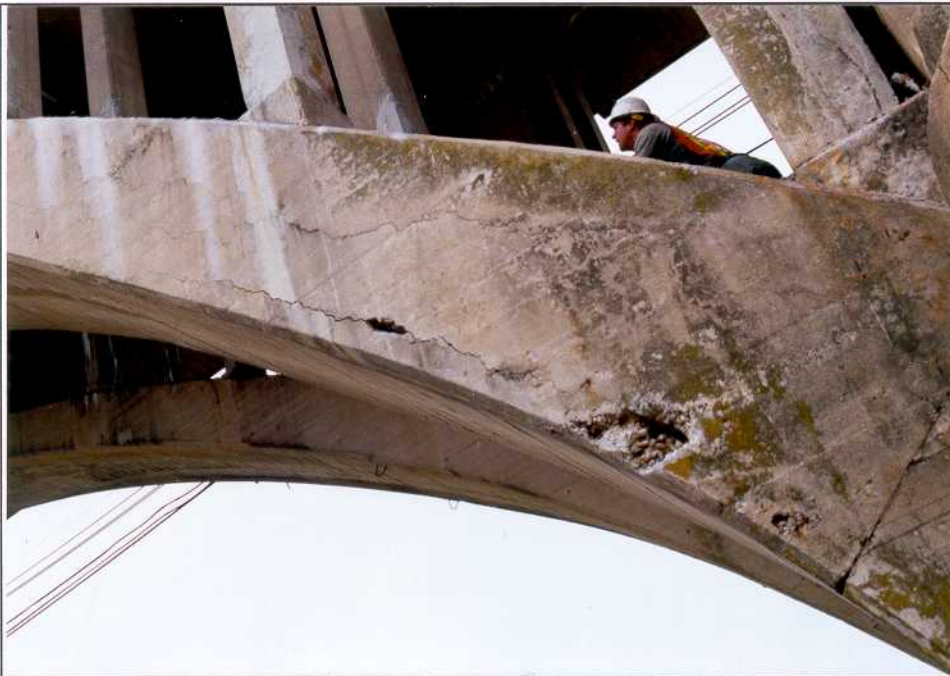
**C215-19**

**PIER 4, SPAN D, DOWNSTREAM SIDE - NOTE SPALLED AND CRACKED CONCRETE ON SIDE OF ARCH.**

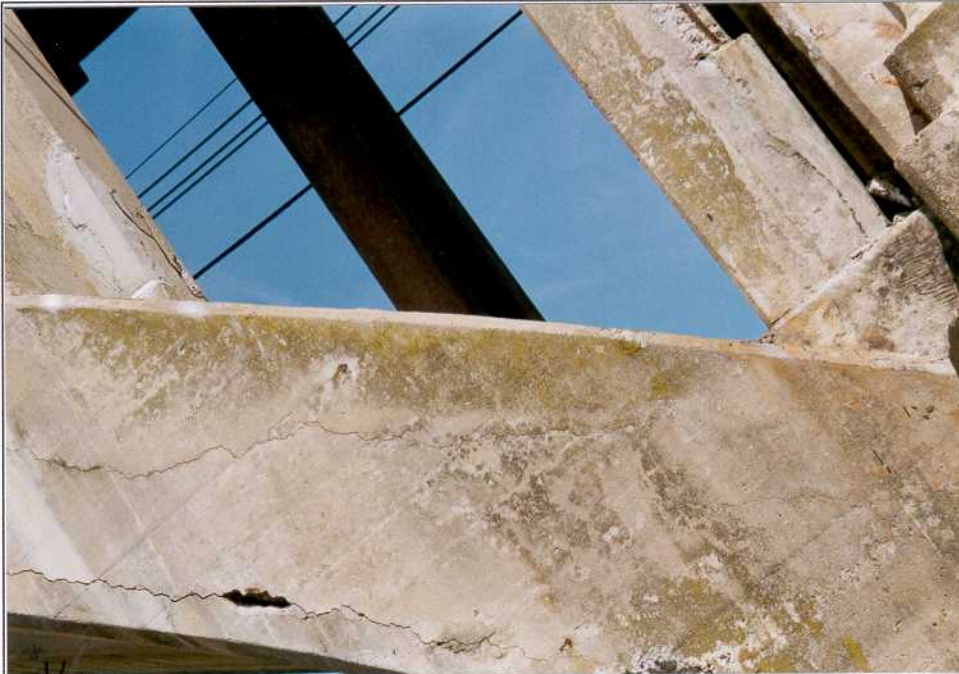
**A104-16**

**DELAMINATIONS, CRACKS AND CORRODED REBAR, SPAN D,  
DOWNSTREAM ARCH NEAR PIER 4.**

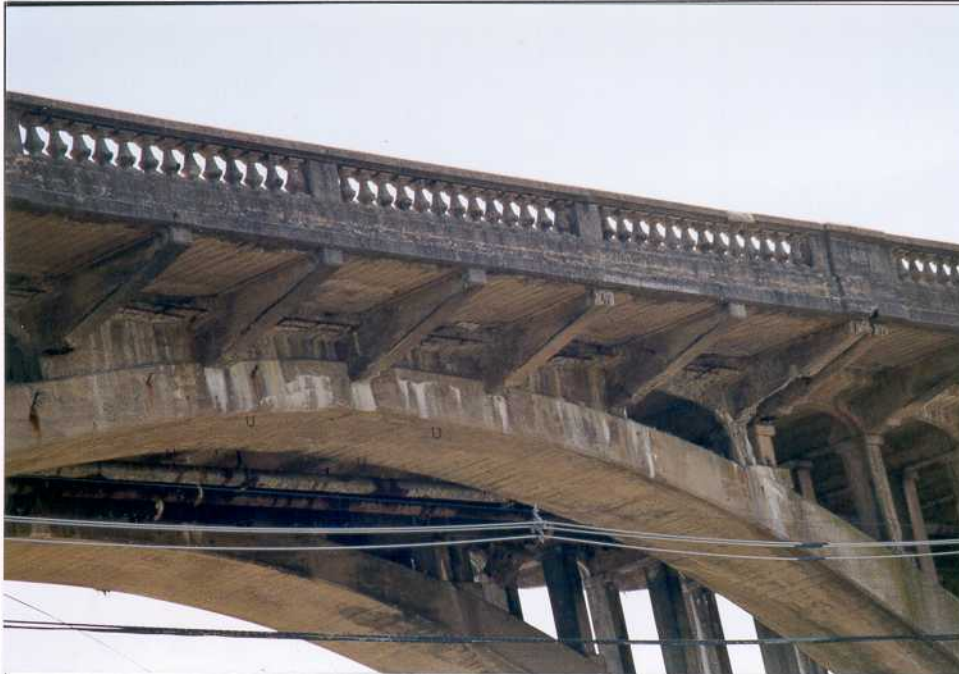
A104-23

**SPALLING, CRACKING AND CORRODED REINFORCING STEEL  
IN UPSTREAM ARCH SPAN E, NEAR CROWN.**

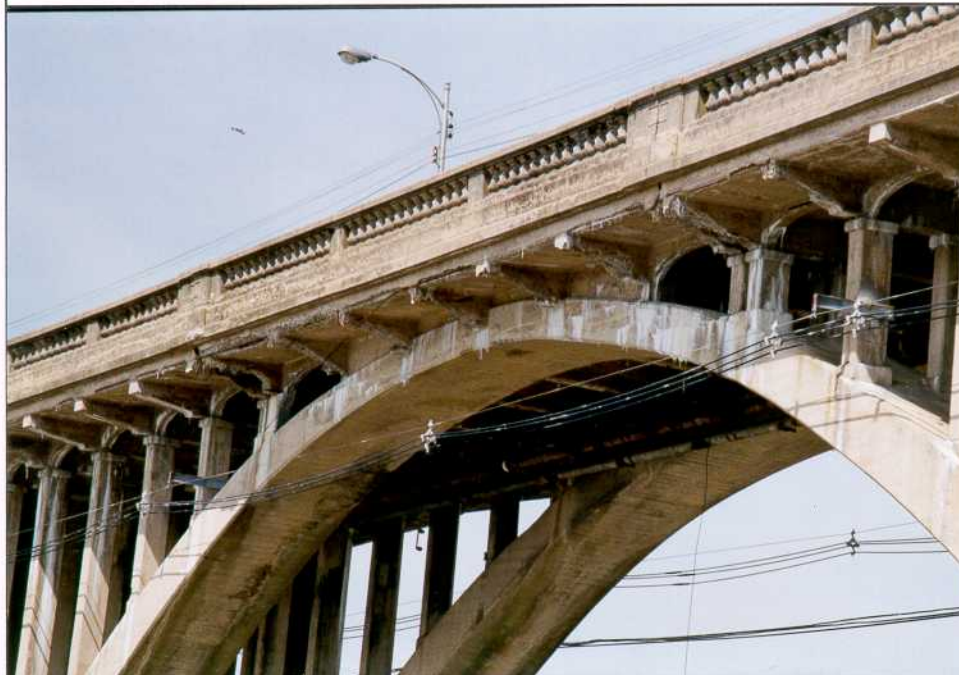
A104-22

**SPALLING, CRACKING AND CORRODED REBAR IN DOWNSTREAM  
ARCH, SPAN E, NEAR CROWN.**

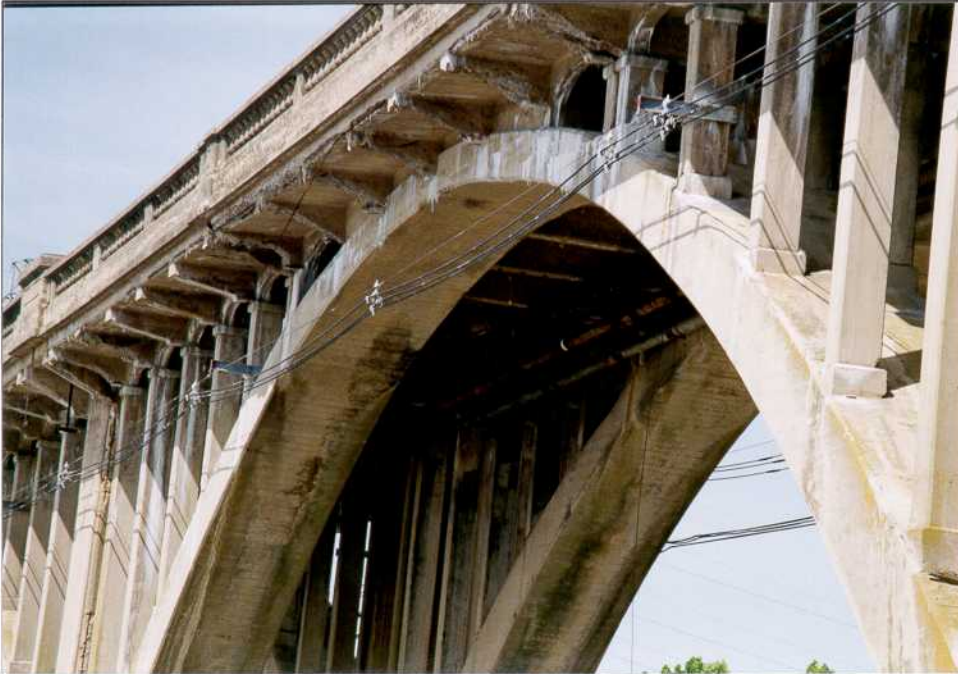
**A104-21**

**SPALLING, CRACKING AND CORRODED REBAR IN DOWNSTREAM ARCH, SPAN E, NEAR CROWN.**

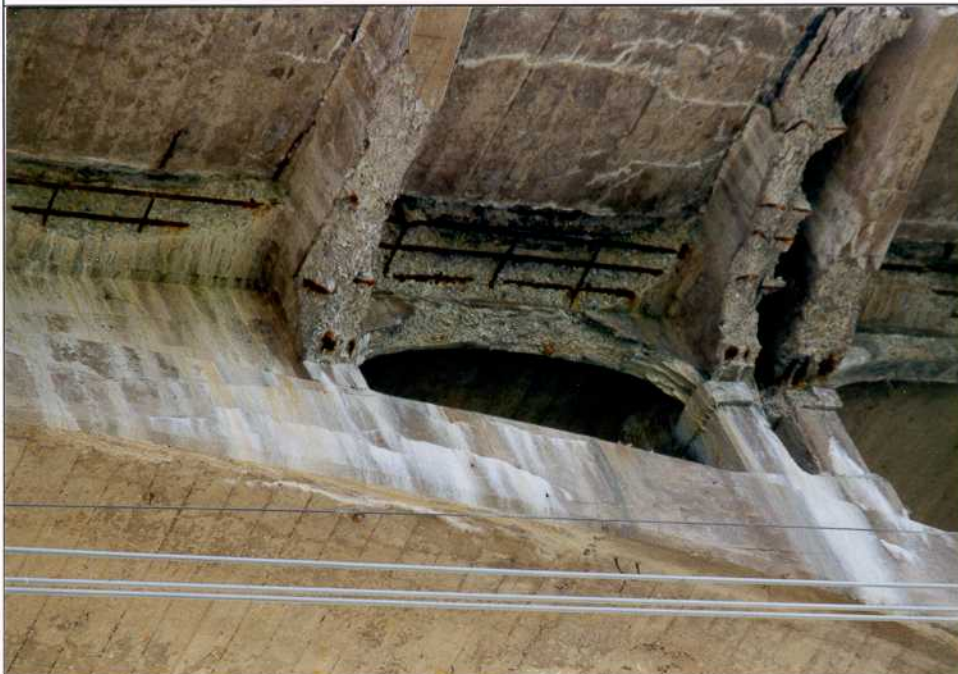
**A104-19**

**SPALLING, CRACKING AND CORRODED REBAR IN DOWNSTREAM ARCH, SPAN E, NEAR CROWN.**

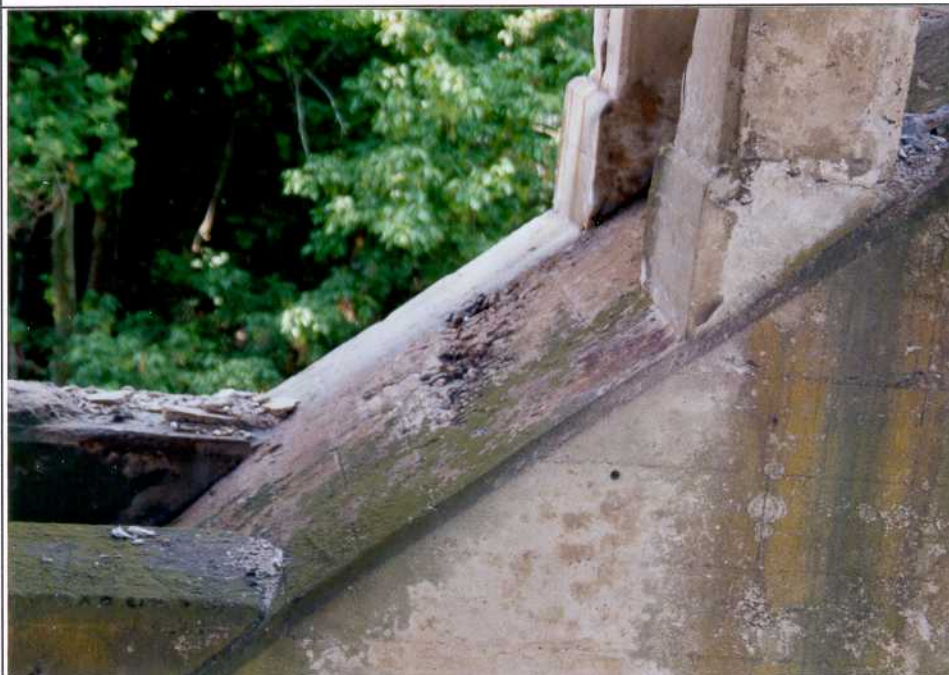
**C217-8**

**DETERIORATED CONCRETE ON TOP OF ARCH, UPSTREAM  
SIDE, SPAN G, NEAR PIER 8.**

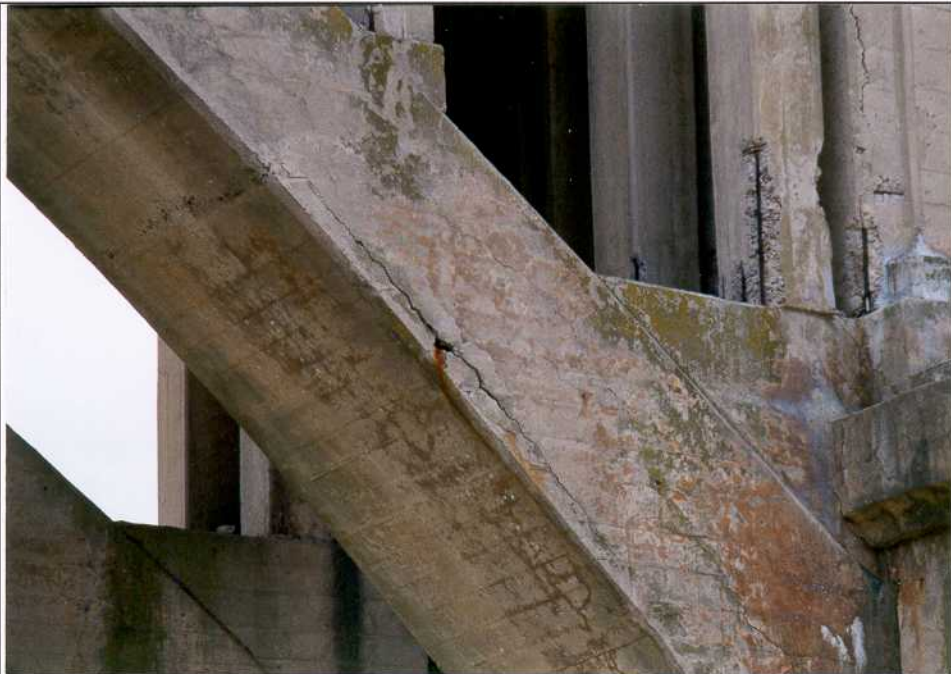
A105-11

**SEVERE DETERIORATION IN DOWNSTREAM ARCH, SPAN G,  
NEAR PIER 7.**

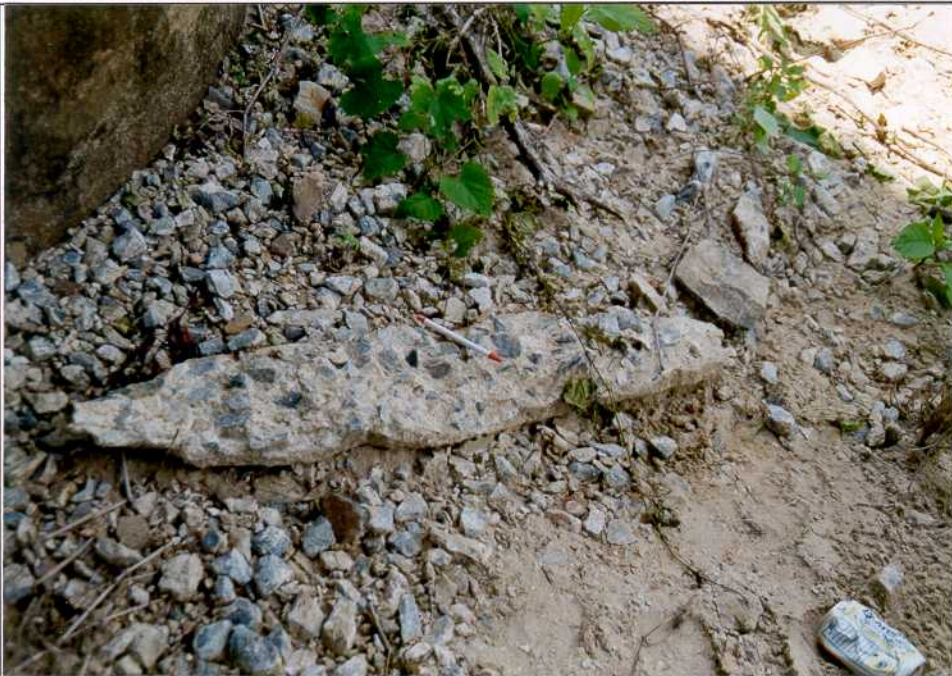
A105-12

**SPALLED CONCRETE LYING ON GROUND NEAR PIER 8, TYP. OF NUMEROUS PIECES THAT HAVE FALLEN.**

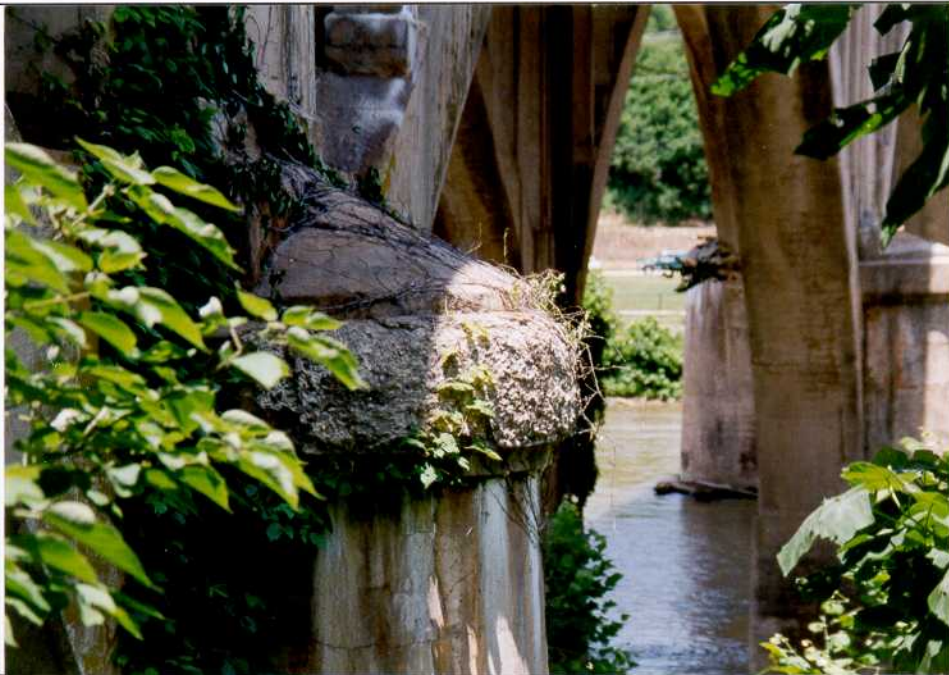
A105-3

**SEVERE SCALE, DOWNSTREAM END, PIER 8 CAP.**

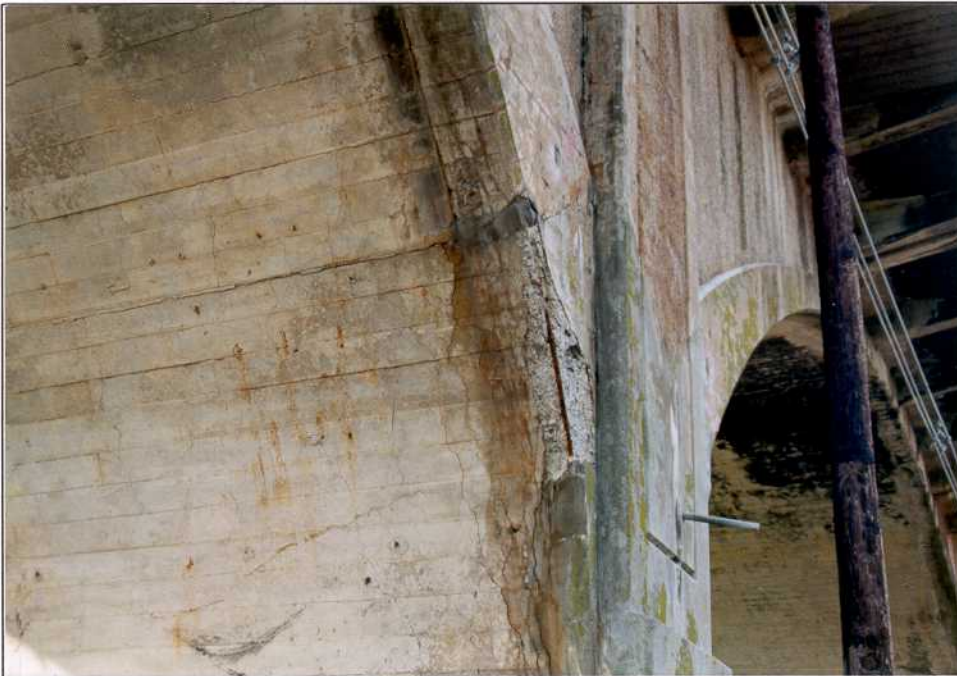
**A104-3**

**SPAN H, UPSTREAM SIDE AT PIER 9 - SEVERE SCALING AND CRACKING AT SPRING LINE.**
